Blower Shelf Modification for RGRA-04,06,07 from 1994 Through August 1999

Due to a design change of the collector box (spacers added to top and bottom of collector box), all RGRA furnaces from 1994 to in 1999 will have to undergo a blower shelf modification to accept a heat exchanger replacment.

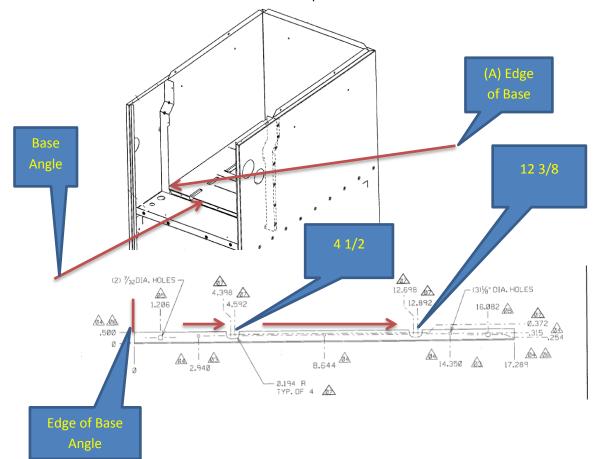
- 1. Remove old heat exchanger
- 2. While looking at the blower shelf locate base angle
- 3. From the inside of the cabinet, at the edge of the base angle (A), measure 4 and 1/2" (Center) and mark, then measure the same way and from same point 12 and 3/8" (center), and mark, using tin snips cut out about aproximately 1/2" long by 5/16" deep notch (half moon shape)
- 4. Insert new heat exchanger making sure heat exchanger will pass freely into the furnace cabinet
- 5. If heat exchanger will not pass freely examine the notches and make sure they are deep enough to allow the heat exchanger to pass.
- 6. Reinsert screws and install components
